NASA TN D-6660

FRETTING WEAR IN TITANIUM, MONEL-400,
AND COBALT — 25-PERCENT MOLYBDENUM
USING SCANNING ELECTRON MICROSCOPY

by Robert C. Bill

Lewis Research Center and
U.S. Army Air Mobility R&D Laboratory
Cleveland, Ohio 44135

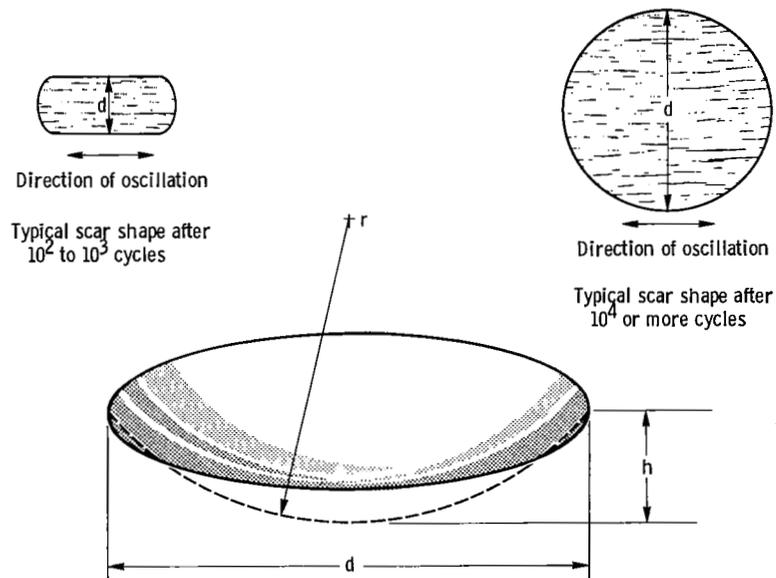
Figure 3. - Model of fretting wear scar, showing direction d across which light section measurements were made.

where d is the wear scar diameter and h is the maximum depth of the scar. The measured quantities d and h are shown schematically in figure 3.

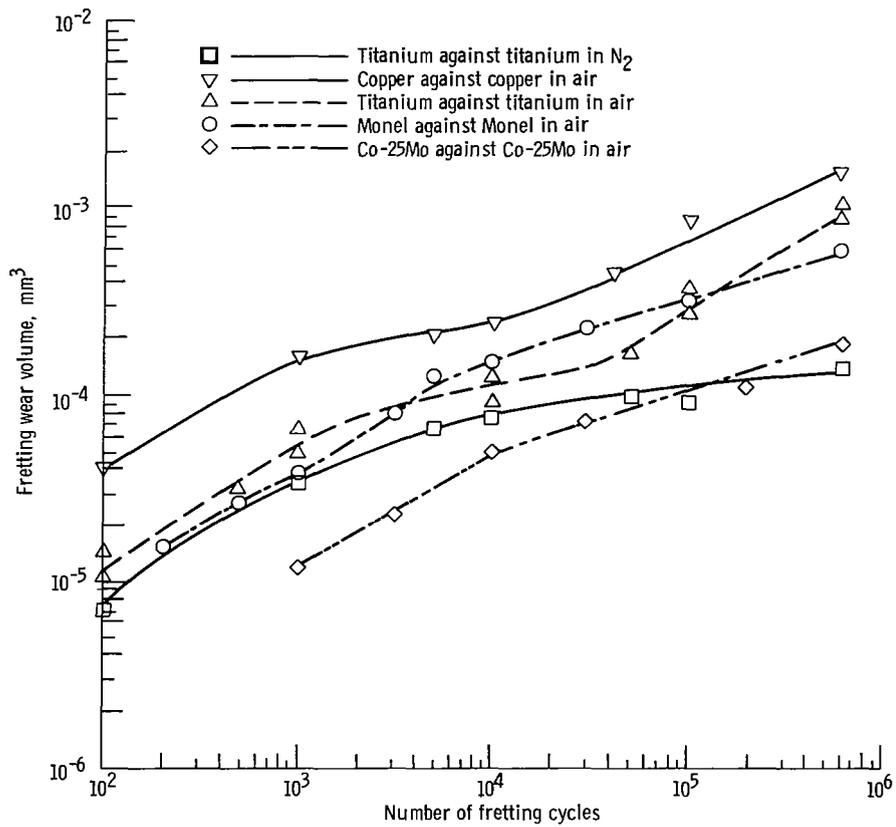
Figure 4. - Fretting wear volume as function of number of fretting cycles. Frequency, 55.8 hertz; normal force, 1.47 newtons (150 g); amplitude, 75×10^{-6} meter.

The volume of the damage scars as a function of the cumulative number of fretting cycles is shown in figure 4. Initially, all specimens show a high rate of increase in wear volume. This rate declines with increasing number of cycles, possibly because

the general stress level decreases as the contact area increases. In the case of copper and titanium in air, an increased rate of damage is observed at fretting cycles greater than 10^4 . Notice that the titanium specimen tested in N_2 showed no increased rate of damage. This suggests that oxidation may be playing an important role in the later stages of the fretting tests on titanium and copper.

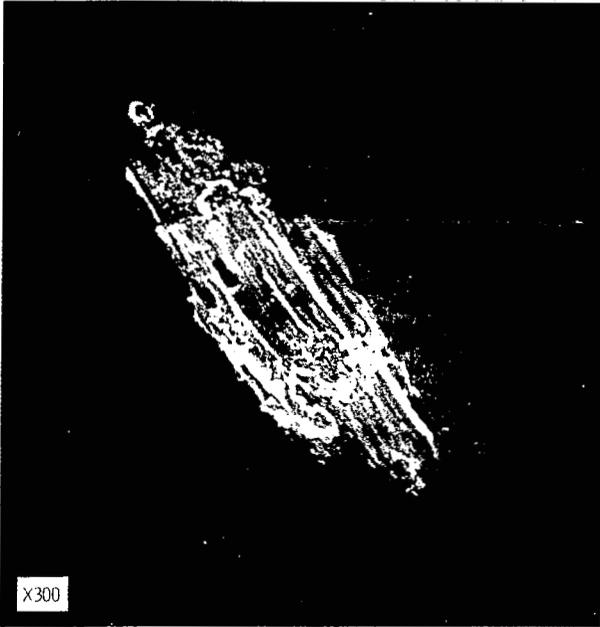
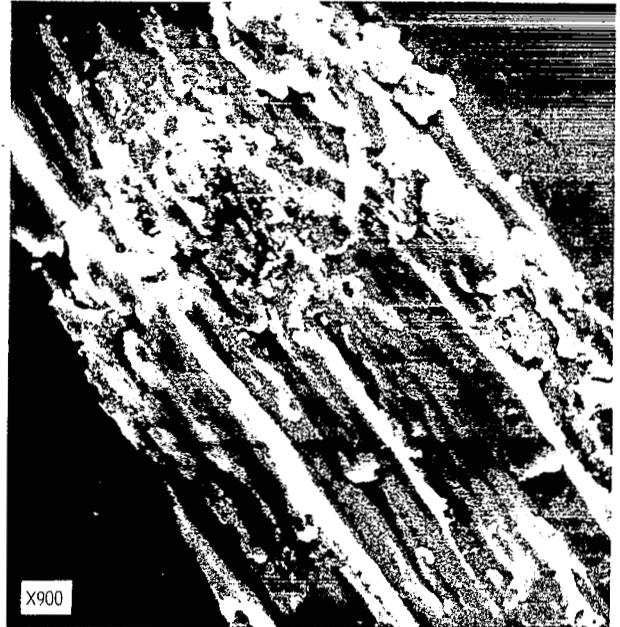
Figure 6. - Scanning electron micrographs of titanium fretted against titanium for 10^2 cycles in room-temperature air. Frequency, 55.8 hertz; normal force, 1.47 newtons (150 g); amplitude, 75×10^{-6} meter.

After 100 fretting cycles, the scars produced on titanium in air (fig. 6) are little different from those produced in N_2 (fig. 7). At this stage, the fretting scars are similar to unidirectional sliding wear scars but are somewhat rougher. This roughness is no doubt due to the reversed motion of the fretting action, but the basic mechanisms operating are probably adhesion - junction growth - fracture of junctions. Also, material buildup around the edges of the scar in figure 6 suggests the action of an extrusion process on a fine scale.

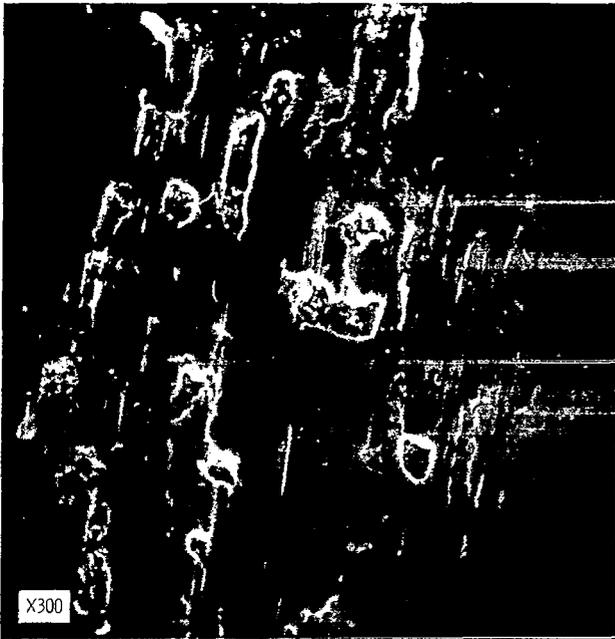
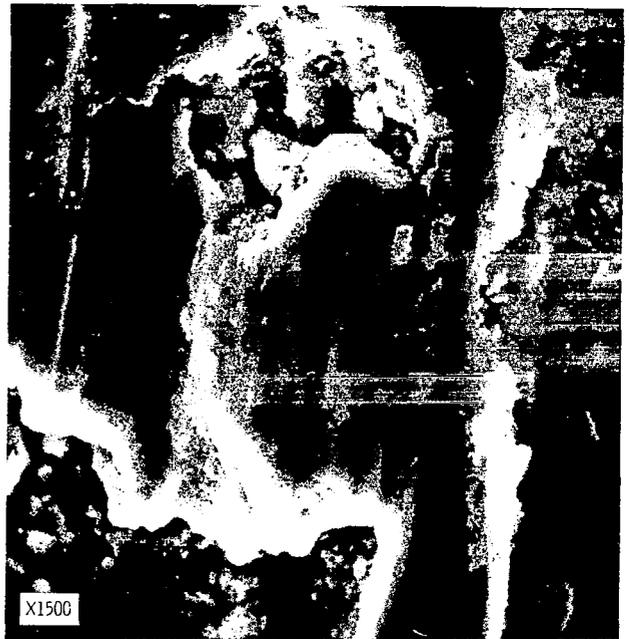
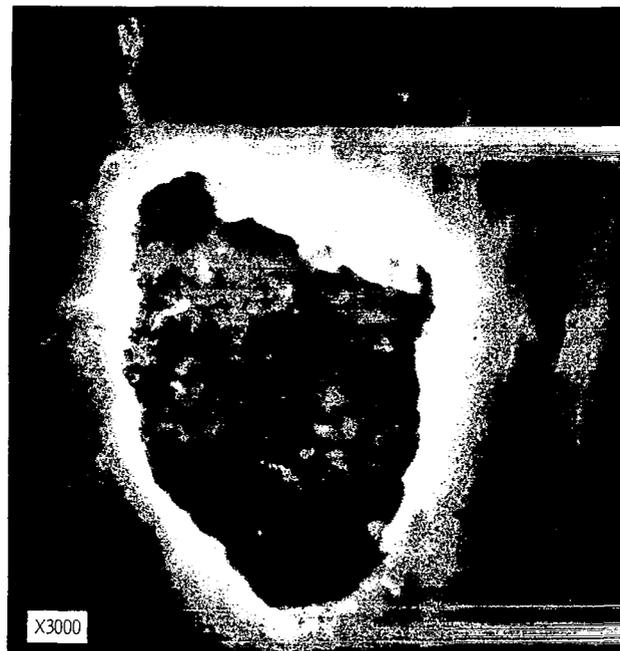
Figure 10. - Scanning electron micrographs of titanium fretted against titanium for 10^4 cycles in nitrogen at room temperature. Frequency, 55.8 hertz; normal force, 1.47 newtons (150 g); amplitude, 75×10^{-6} meter.

The scar produced by 10 000 cycles in N_2 (fig. 10) is essentially the same as the one resulting from 1000 cycles in N_2 (fig. 7). Similar spall-like pits are present, and the surrounding surface regions are fairly smooth.

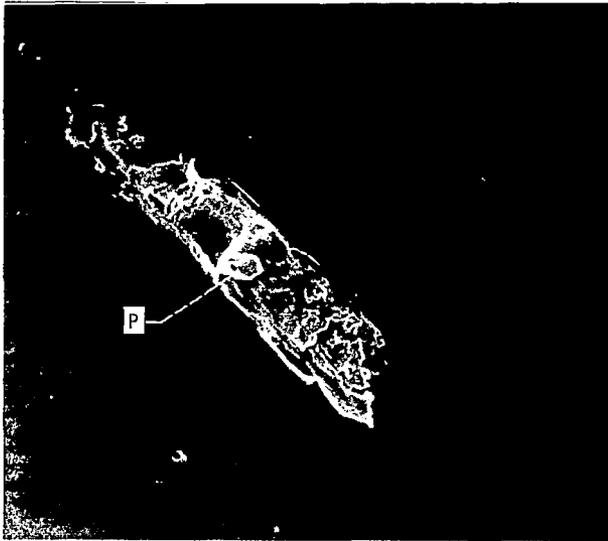
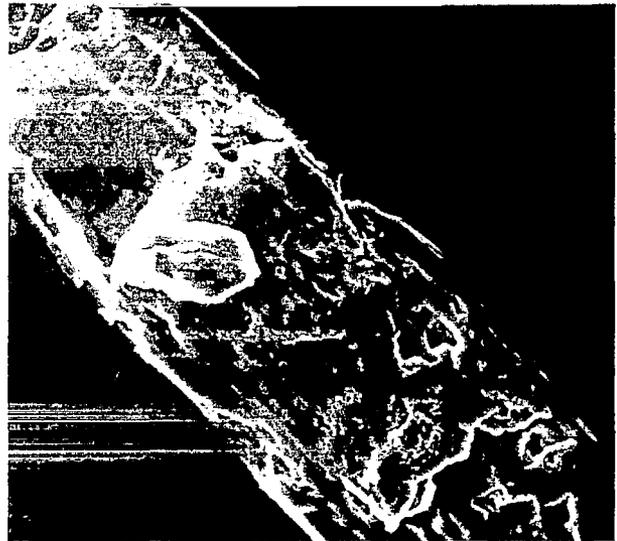
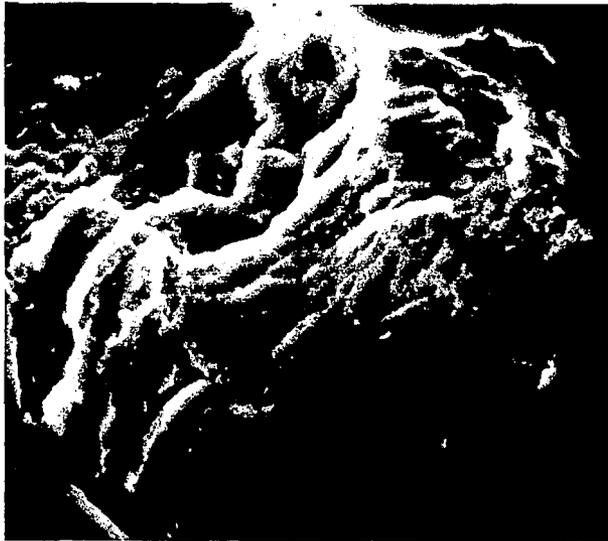
Figure 13. - Scanning electron micrographs of Monel fretted against Monel for 10^2 cycles in air at room temperature. Frequency, 55.8 hertz; normal force, 1.47 newtons (150 g); amplitude, 75×10^{-6} meter. (Note transfer particle (P) in (a) and (b).)

After 100 cycles, Monel-400 (fig. 13) showed evidence that the adhesion - junction growth - fracture mechanism suggested for titanium is active. Of particular interest is the prominent particle in the center of the damage scar shown in figures 13(a) and (b). This particle may have been either transferred from the mating bullet or plucked out of the flat surface and bent back, hinge like, to its observed position. In any case it appears to be firmly adhering to the flat surface at its upper edge. Another significant feature is the spall-like pit with a serrated bottom visible in figure 13(c). From

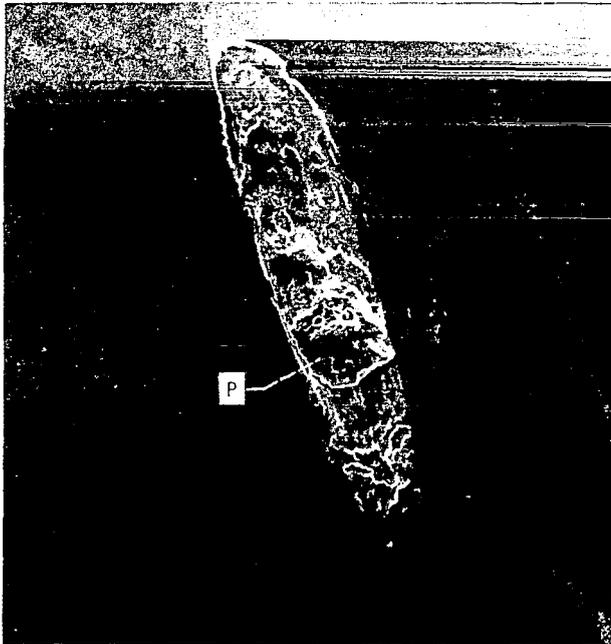
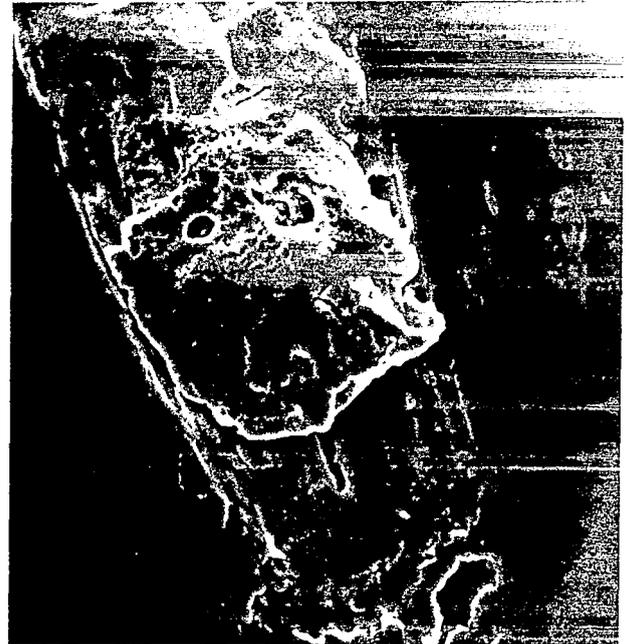
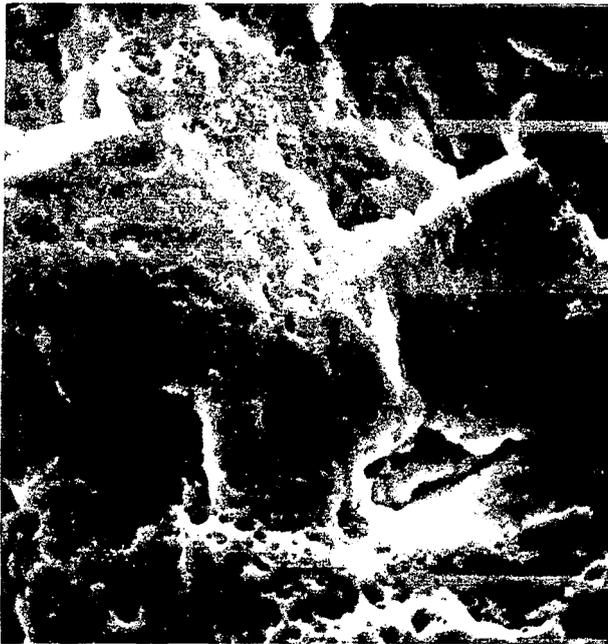
Figure 14. - Scanning electron micrographs of Monel fretted against Monel for 10^3 cycles in air at room temperature. Frequency, 55.8 hertz; normal force, 1.47 newtons (150 g); amplitude, 75×10^{-6} meter. (Note what appears to be a transfer fragment (P) in (a) and (b).)

Figure 14 shows the surface of the Monel specimen after it was subjected to 1000 fretting cycles. The general features are similar to those of the scar produced by 100 cycles. The large fragment (fig. 14(a)), as wide as the fretting scar, shows strong evidence of having been transferred from the mating spherical surface. The roughened features on the upper surface of the fragment, and similar features on the wear scar just above the fragment, are typical of the elongated dimples produced in ductile fracture.

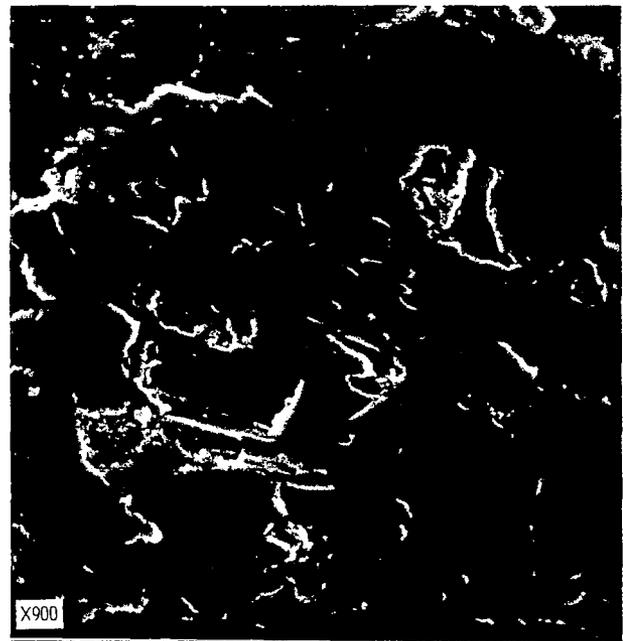
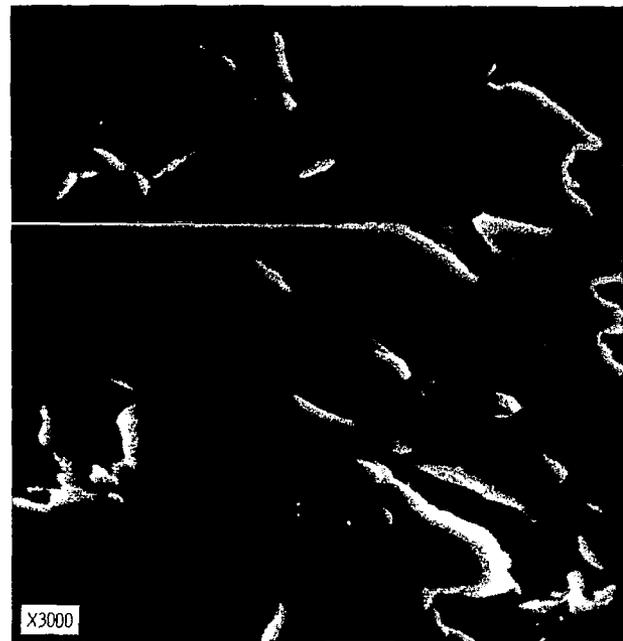
Figure 15. - Scanning electron micrographs of Monel fretted against Monel for 10^4 cycles in air at room temperature. Frequency, 55.8 hertz; normal force, 1.47 newtons (150 g); amplitude, 75×10^{-6} meter.

There is considerable particulate debris present around the edges of the fretting scar on Monel after 10 000 cycles (fig. 15). This debris buildup, coinciding roughly with the onset of accelerated wear, may mark the onset of the operation of an oxide particle abrasion mechanism.

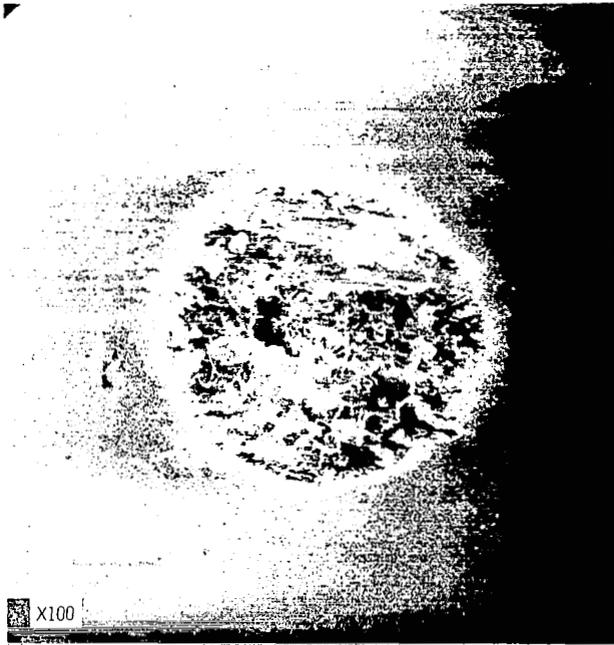
Figure 17. - Scanning electron micrographs of Monel fretted against Monel for 10^5 cycles in air at room temperature. Frequency, 55.8 hertz; normal force, 1.47 newtons (150 g); amplitude, 75×10^{-6} meter.

Figures 16 and 17 show the fretting scars produced on Monel by 5×10^4 and 10^5 cycles, respectively. The fine crack network and surface disintegration indicate a simultaneous surface oxidation and fatigue action. The crack network is typical of the surface features produced as a material oxidizes, when the surface oxide film has a smaller specific volume than the bulk material; this puts the oxide film in tension and generally results in cracking. In addition to the crack network, the remnants of disintegrating spall pit edges may be seen. These features are similar to those observed in titanium after 1000 or 10 000 cycles. Thus, there is some evidence that the debris generation in the latter portion of the fretting process of Monel may come about from both a fatigue corrosion cracking of the surface pit edges and a direct surface oxidation mechanism.

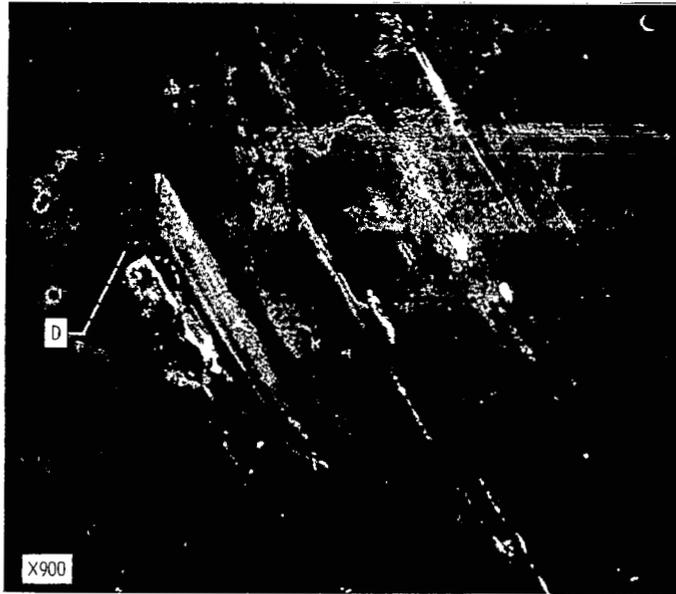
Figure 18. - Scanning electron micrograph of Co-25Mo fretted against Co-25Mo for 10^2 cycles in air at room temperature. Frequency, 55.8 hertz; normal force, 1.47 newtons (150 g); amplitude, 75×10^{-6} meter. (Note the debris (D) around the scratches.)

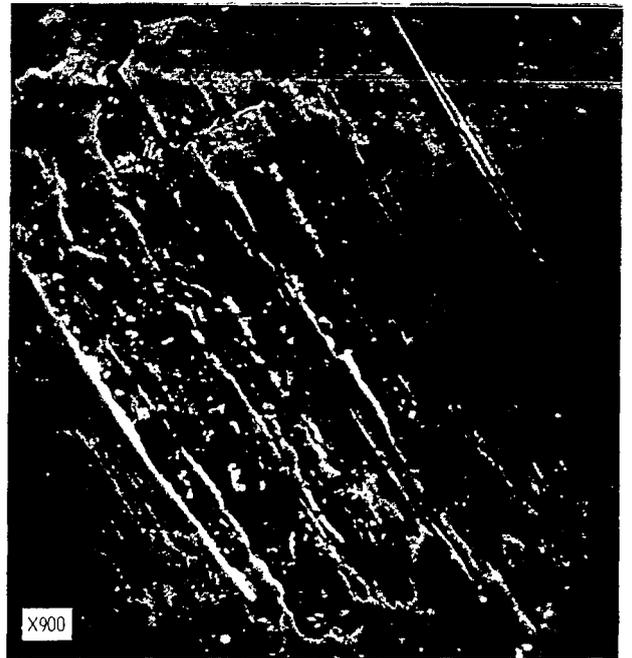
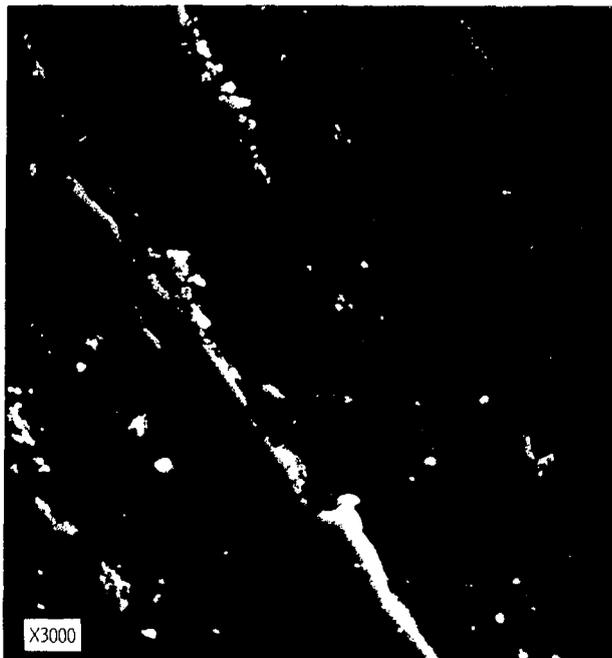
Figure 20. - Scanning electron micrographs of Co-25Mo fretted against Co-25Mo for 10^4 cycles in air at room temperature. Frequency, 55.8 hertz; normal force, 1.47 newtons (150 g); amplitude, 75×10^{-6} meter.

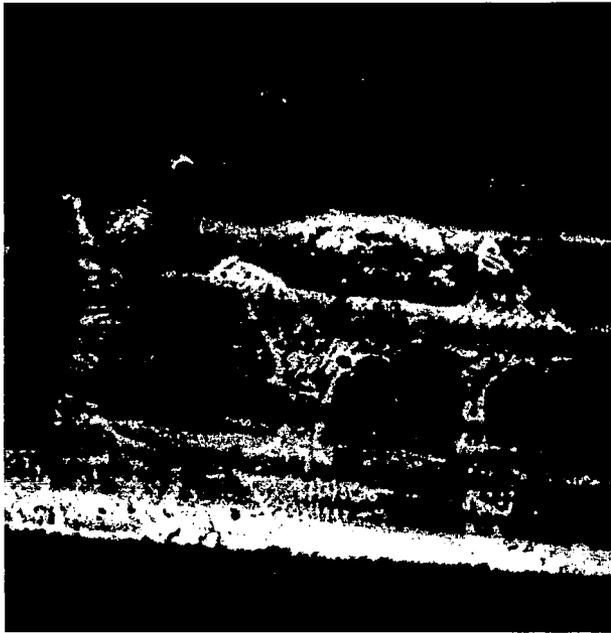
Figure 21. - Scanning electron micrographs of Co-25Mo fretted against Co-25Mo for 2×10^5 cycles in air at room temperature. Frequency, 55.8 hertz; normal force, 1.47 newtons (150 g); amplitude, 75×10^{-6} meter.

After 2×10^5 cycles (fig. 21) the scratches have nearly vanished, and some dark oxide debris may be seen at the edges of the damage scar (fig. 21(a)). The surface

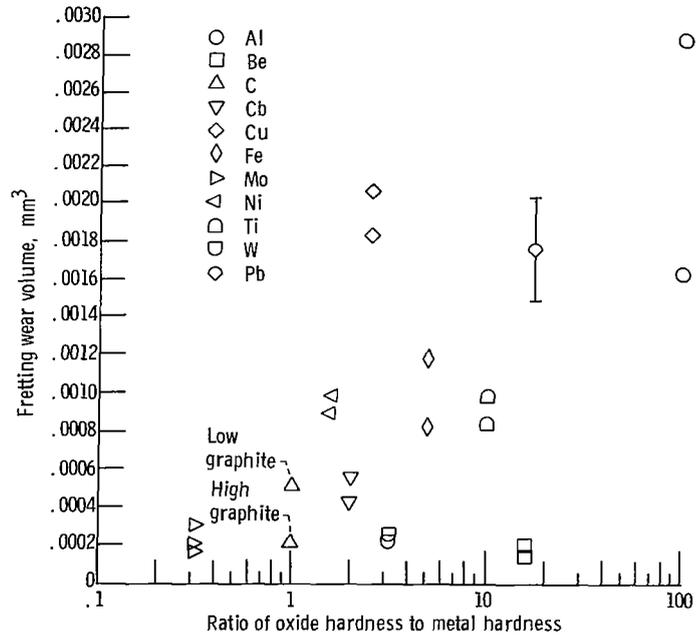
Figure 22. - Fretting wear volume after 6×10^5 cycles as function of ratio of oxide hardness to metal hardness.

With a few exceptions (tungsten and beryllium), the trend seems to be one of increased fretting damage with increased ratio of oxide hardness to metal hardness. In the case of beryllium and tungsten, very little debris was observed; the real ratio of debris hardness to metal hardness may therefore be close to 1. For purposes of comparison, a high graphitic carbon and a low graphitic carbon are included. Their results lie close to the expected value for a metal with a 1:1 oxide- to metal-hardness ratio. This should not be surprising, as carbon produces no solid oxide debris and any debris present in the contact region would be solid carbon.

One must, of course, be cautious in drawing conclusions from figure 22. Oxidation rates are not considered, nor are the mechanical properties of the metal aside from the oxide- to metal-hardness ratio. It is an indication, though, that the abrasive aspect of fretting wear should be considered.
